**Client Report :**

Comparison of home grown  
and imported softwood for  
Timber Frame market –  
Final Report

Client report number  
215 - 340

30<sup>th</sup> March 2004

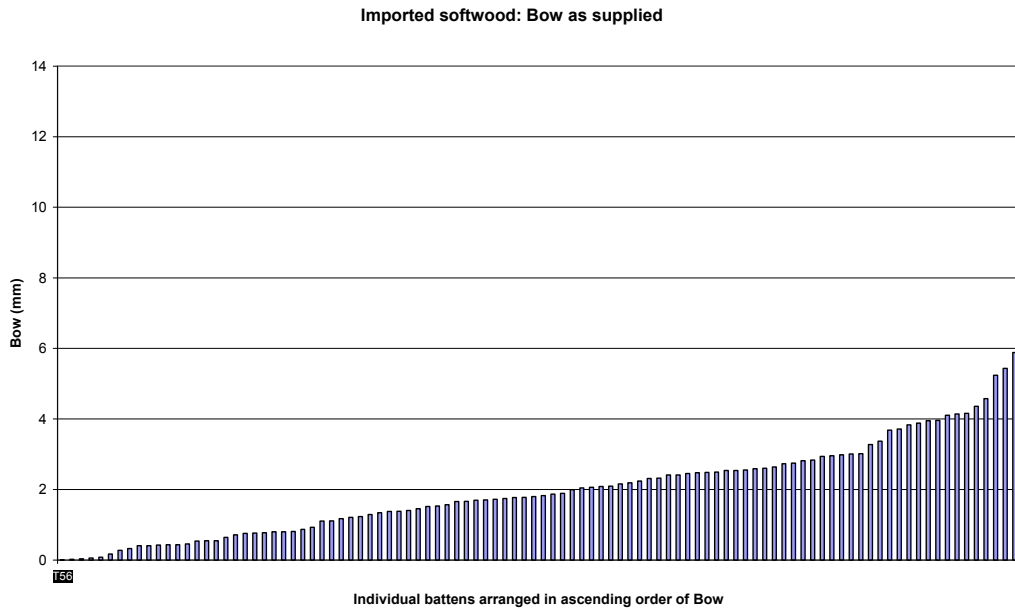
**2.1 Distortion as supplied - Bow.** Figures 1 and 2 (below) show the measured bow graphs of the Imported (coloured blue) and Home grown material (coloured red)

Figures 1 and 2 Comparison of Bow at supplied moisture content

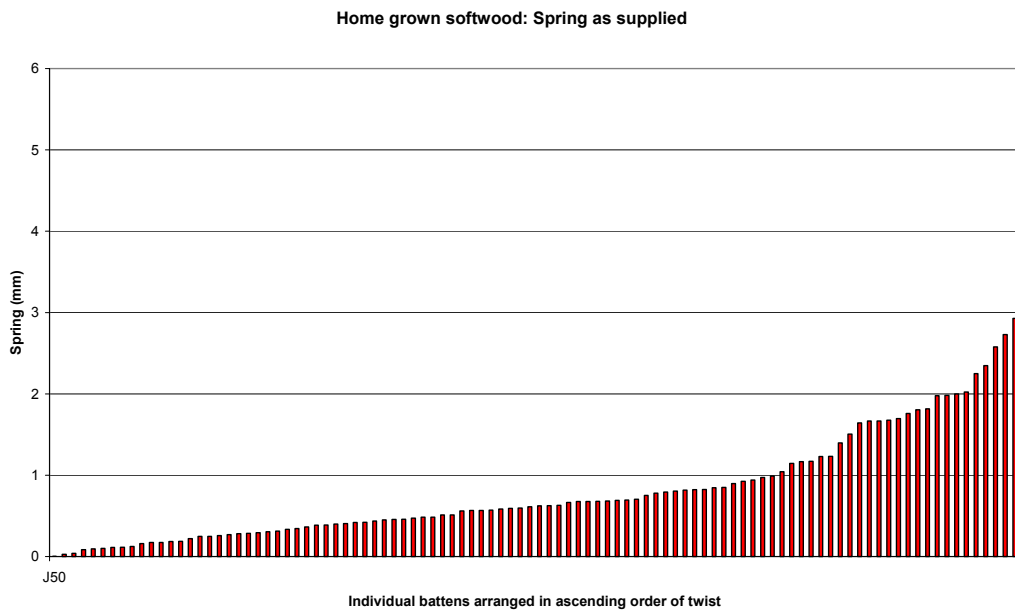
**2.2 Distortion as supplied - Spring.** Figures 3 and 4 (below) show the measured spring graphs of the Imported (coloured blue) and Home grown material (coloured red)

Figures 3 and 4 Comparison of Bow at supplied moisture content

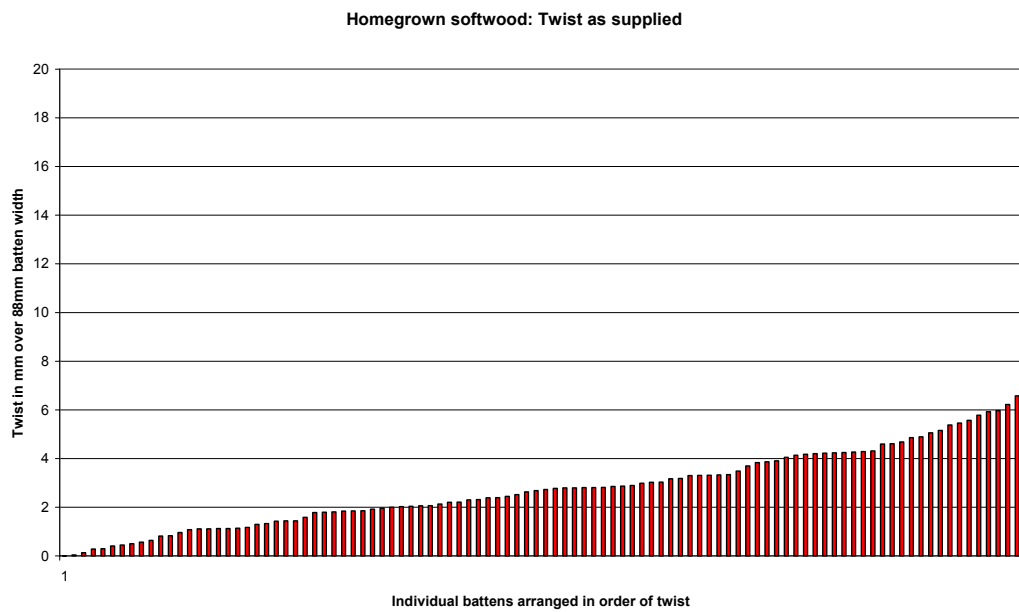
**2.3 Distortion as supplied - Twist.** Figures 5 and 6 (below) show the measured twist graphs of the Imported (coloured blue) and Home grown material (coloured red)

Figures 5 and 6 Comparison of twist at supplied moisture content

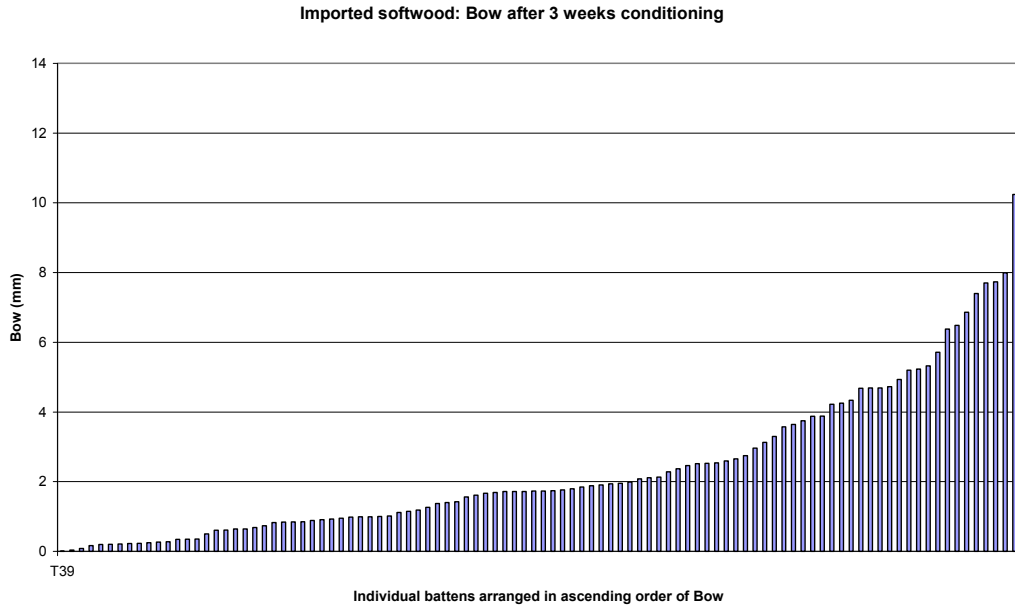
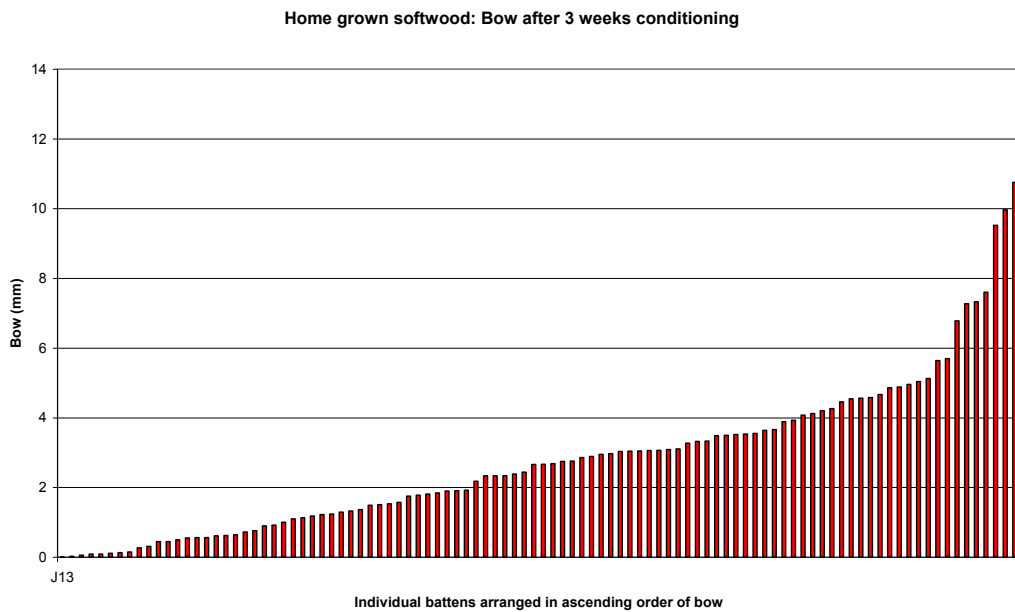
**2.4 Distortion after 3 weeks conditioning - Bow.** Figures 7 and 8 (below) show the measured bow graphs of the Imported (coloured blue) and Home grown material (coloured red)

Figures 7 and 8 Comparison of Bow after 3 weeks conditioning

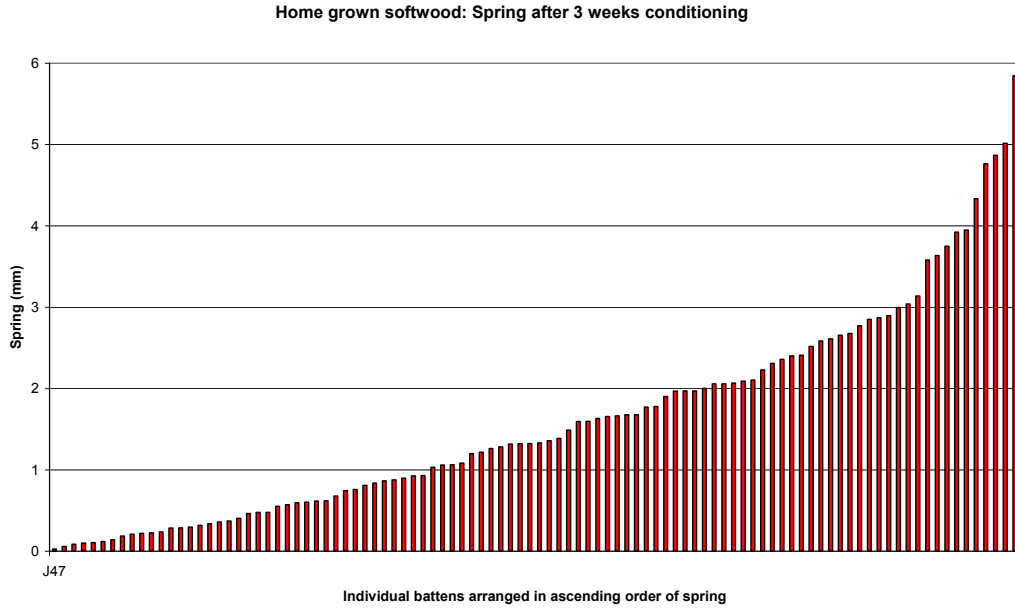
**2.5 Distortion after 3 weeks conditioning - Spring.** Figures 9 and 10 (below) show the measured spring graphs of the Imported (coloured blue) and Home grown material (coloured red)

Figures 9 and 10 Comparison of Spring after 3 weeks conditioning

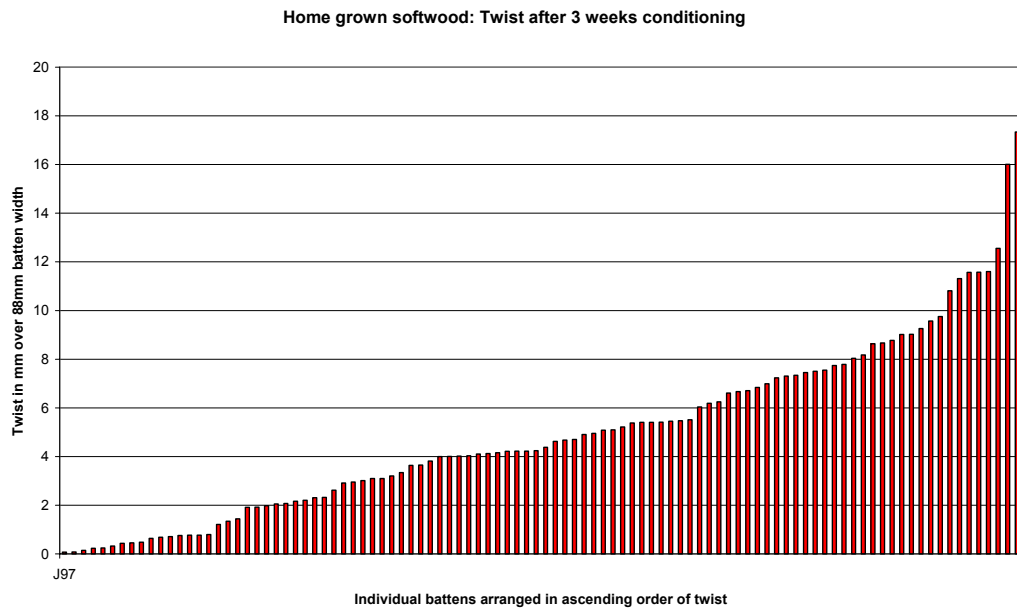
**2.6 Distortion after 3 weeks conditioning - Twist.** Figures 11 and 12 (below) show the measured bow graphs of the Imported (coloured blue) and Home grown material (coloured red)

Figures 11 and 12 Comparison of Twist after 3 weeks conditioning

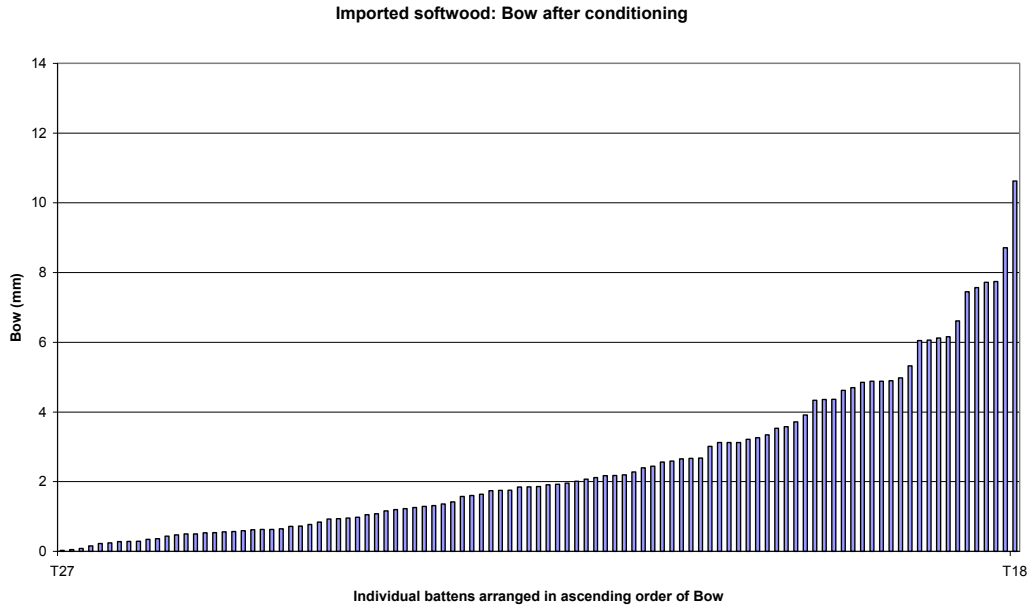
**2.7 Distortion after full conditioning - Bow** Figures 13 and 14 (below) show the measured bow graphs of the Imported (coloured blue) and Home grown material (coloured red)

Figures 13 and 14 Comparison of Bow after full conditioning

The higher bow and spring at conditioned (low) moisture content in the home-grown timber was determined to be caused by the presence of significant levels of compression wood in about 30% of the samples. The level of twist was 20% higher in the home grown timber after unrestrained conditioning.

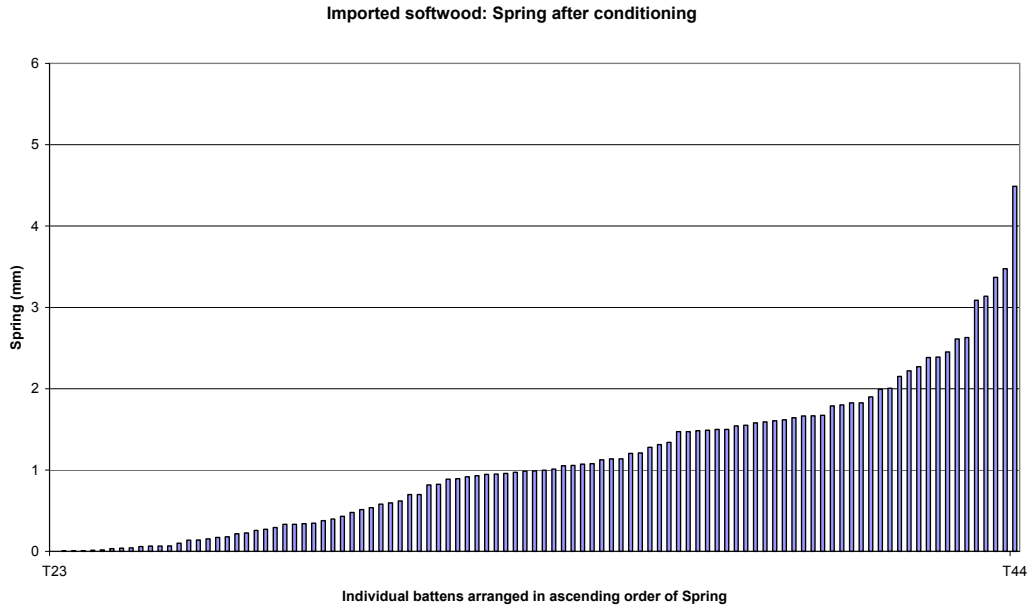
**2.8 Distortion after full conditioning - Spring** Figures 15 and 16 (below) show the measured spring graphs of the Imported (coloured blue) and Home grown material (coloured red)

Figures 15 and 16 Comparison of Spring after full conditioning

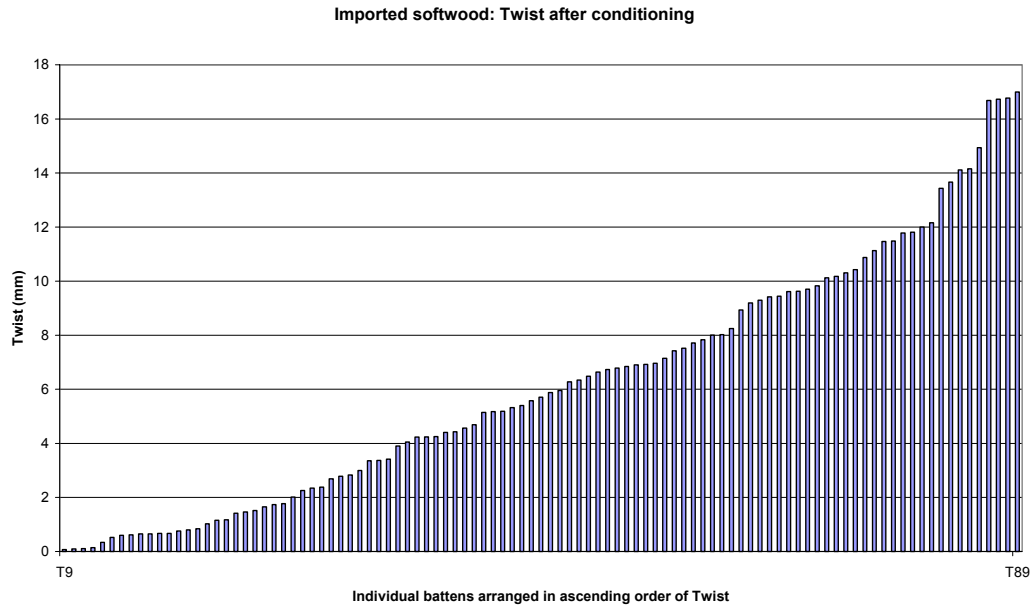
**2.9 Distortion after full conditioning - Twist** Figures 17 and 18 (below) show the measured twist graphs of the Imported (coloured blue) and Home grown material (coloured red)

Figures 17 and 18 Comparison of Twist after full conditioning

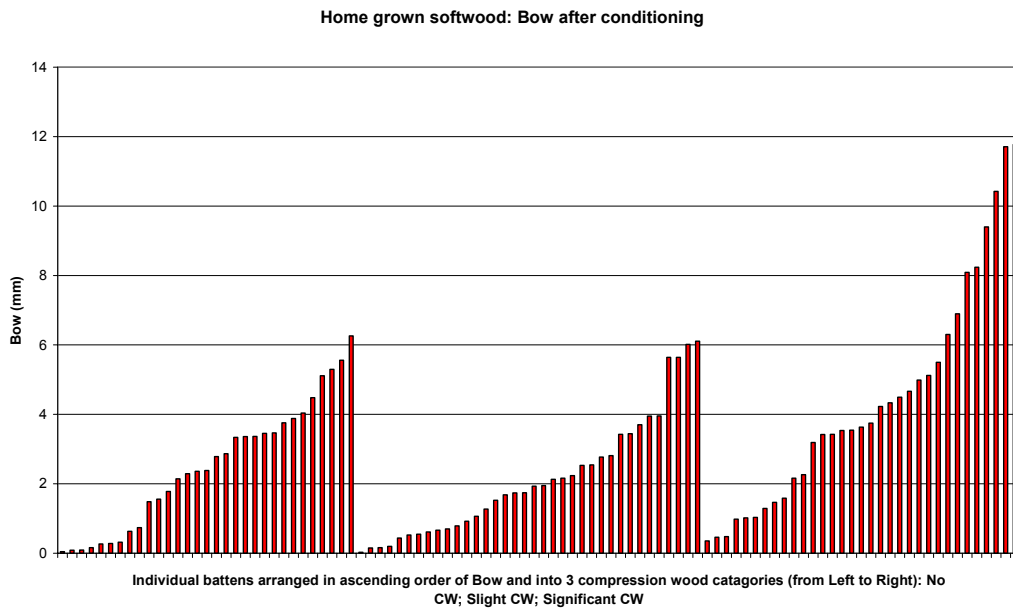
Figures 19, 20 and 21 (below) show bow, spring and twist at low moisture content, arranged into three compression wood categories and ascending order of distortion.

**Figure 19: Compression Wood Content and Bow**

It is clear that compression wood is the factor in both bow and spring, but not twist as would be expected.

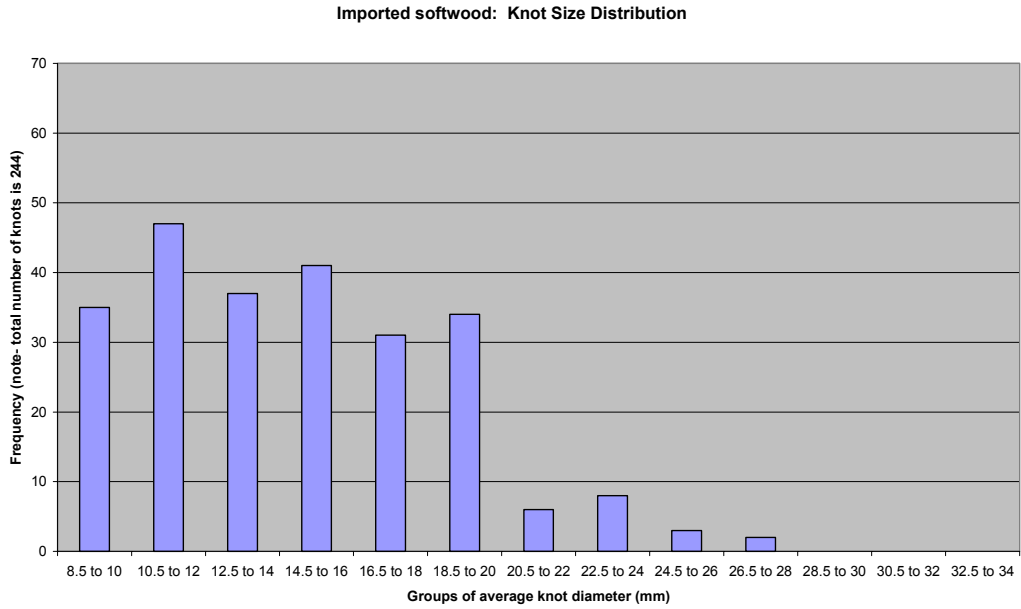
Figures 22 and 23 (below) show the knot size/distribution graphs for both sets of timber:

**Figures 22 (top) and 23: Comparison of knot size and frequency**

- The proportion of knots in terms of total knot area on one face of the home grown timber was 60% greater than that of the imported material.
- The UK timber contains 38% more knots over 10mm in size than the imported material.
- The average knot size is 12% larger in the home grown timber compared with the imported.

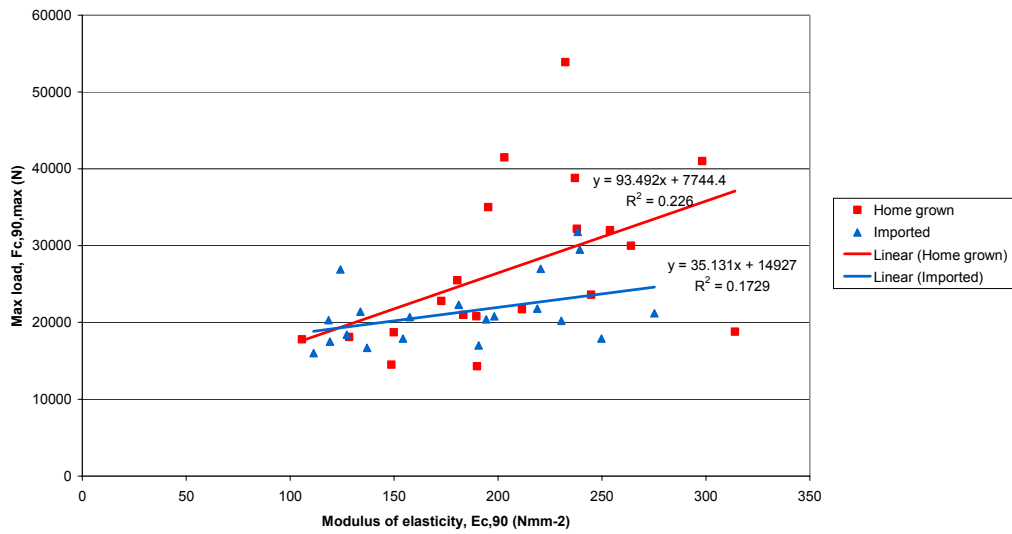
Figures 24 and 25 (below) show comparative results of Load v MOE and Compressive stress v MOE, respectively, for both sets of timber.

Elastic modulus against Max load in compression perpendicular to grain with bottom rail sample orientation.

Figures 24 (top) and 25: Compression Test Results

The high modulus of elasticity and maximum compressive stress found for the UK spruce is likely to be due to high knot contents. Both sets of samples were conditioned to 14% moisture content.

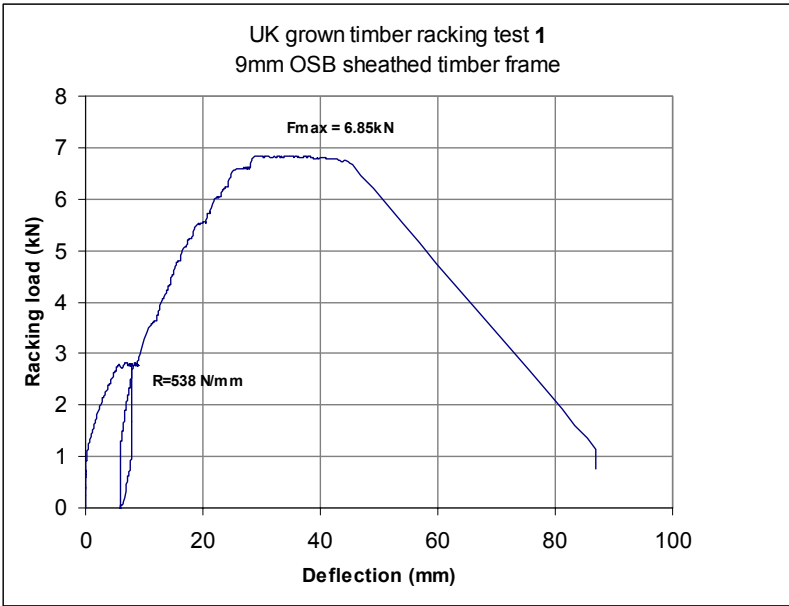
Table 5 gives the test reduction and calculation of basic racking resistance (BRR). The test results for the two panels are shown graphically in Figures 26 and 27.

Figure 26: Test results panel 1

The panels were found to fall below the required racking resistance by about 20%, with the most likely explanation that the sheathing fixing nails had been over-driven.

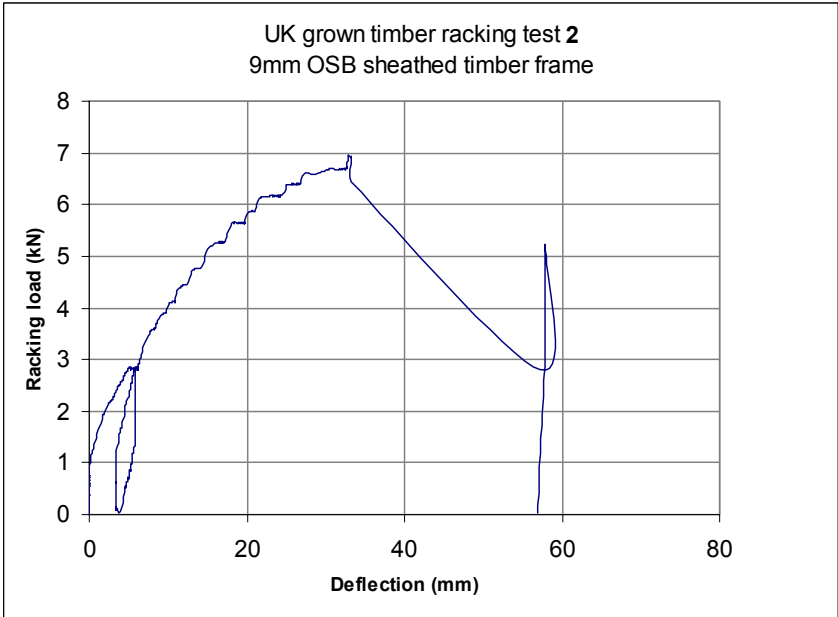
Figure 27: Test results panel 2

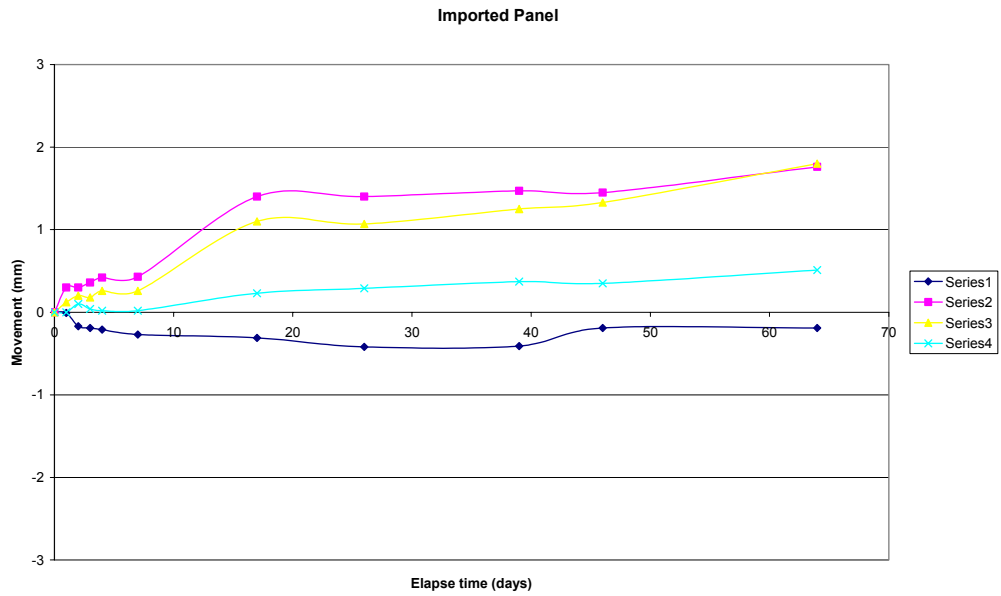
Figures 31 and 32 (below) show the results of the conditioning tests with data series as defined in Table 6:

**Figure 31: Imported timber panel test results**

Both the imported and UK timber panels were observed to have positive movement for series 1 and 2 data (which means that on the left hand side of the panel there was movement to the left and outward). However, the level of movement is so low as to make it impossible to draw any firm conclusions on the nature of the distortion, other than to say that it is in practical terms negligible. Clearly, and as expected, the restraint afforded by the panel construction prevents the distortion observed on unrestrained battens for bow, spring and twist.

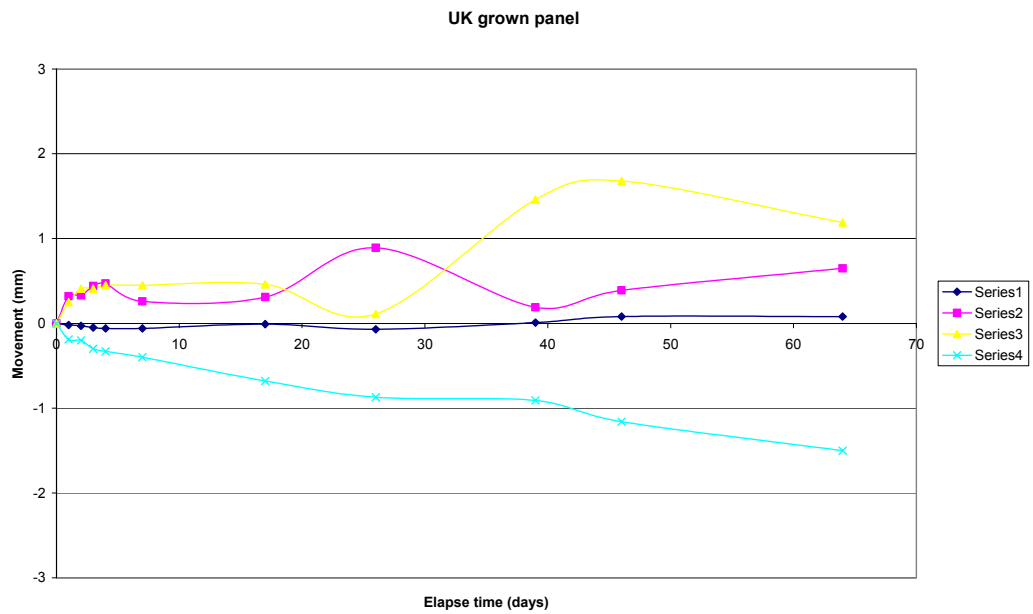
**Figure 32: UK timber panel test results**

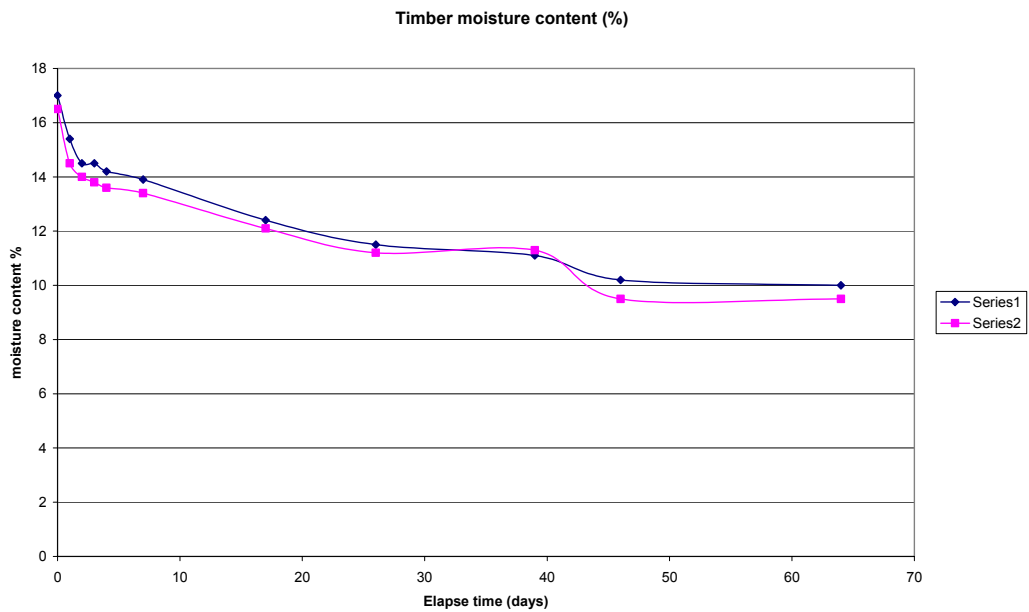
Figure 33 (below) shows the recorded timber moisture contents, with the anticipated fall from supplied moisture content ie about 18% to 10% which is normal for timber inside a continuously heated building but actually below that expected for a timber frame inner leaf.

**Figure 33: Timber moisture contents during the test**

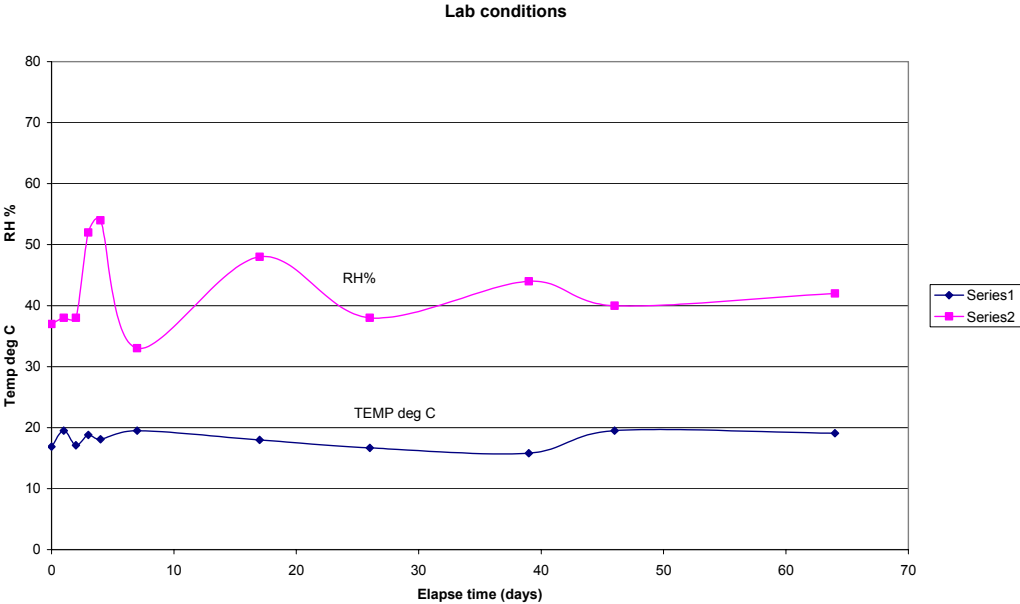
Figure 34 (below) shows the fairly constant laboratory conditions during the experiment:

Figure 34: Laboratory conditions
