INTERNAL PROJECT INFORMATION NOTE 10/08

Title: CCF Harvesting Method Development: Harvester Head Visibility

Number: 1200A/56/07

Date: August 2008

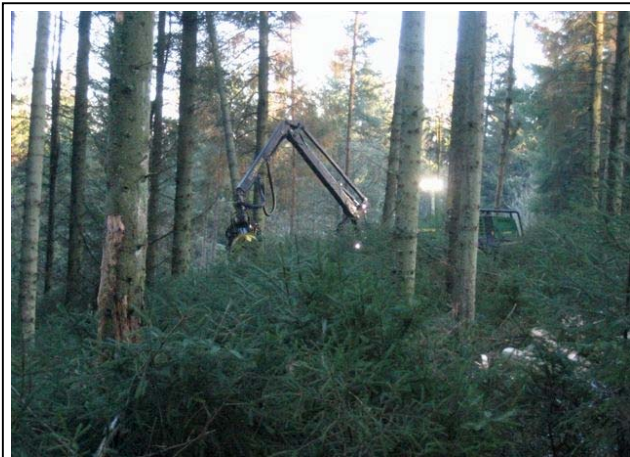
Figure 1 Harvester felling mature Sitka spruce overstorey amongst dense natural regeneration

In Continuous Cover Forestry (CCF) the presence of dense natural regeneration can reduce visibility during harvesting (Figures 1 and 2). Many of the elements in a harvester work cycle depend on good unobstructed vision of the work area and reduced visibility is therefore a potential limiting factor on speed and safety. This IPIN identifies harvesting methods and technological improvements for harvesting in stands with limited visibility due to the presence of natural regeneration.

During 2007 a time study was carried out to determine outputs and costs in a CCF thinning in Clocaenog forest, North Wales¹ (Figure 1). Visibility was constrained by natural regeneration and poor lighting caused by starting and finishing the working day in the dark (see Appendix 1 for basic stand details and harvester specification use in this study).

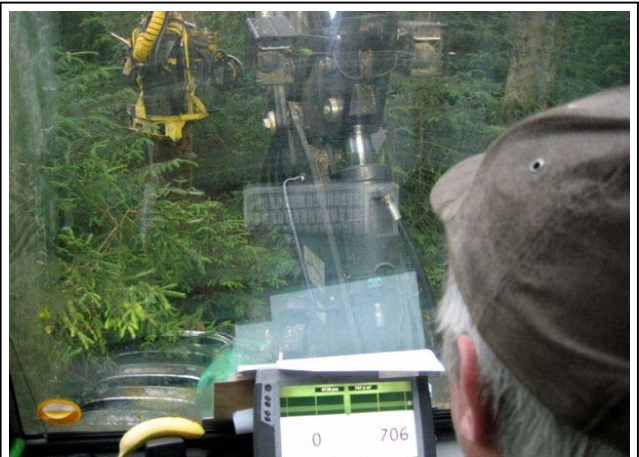
Figure 2 Dense natural regeneration restricting the operator's view to the base of the tree during felling

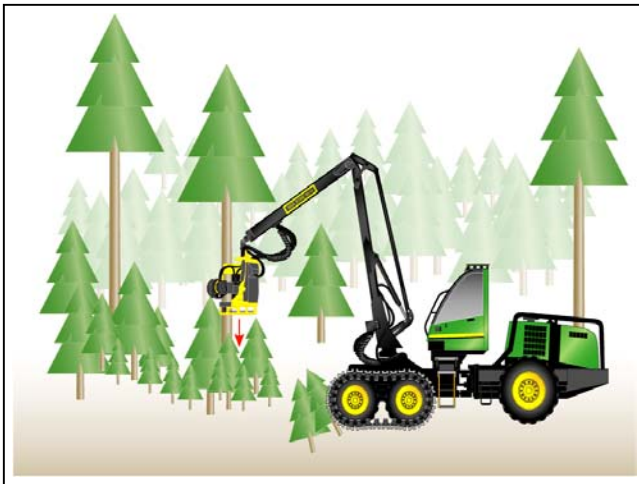
Figure 3 Placing the felling head high up the stem and running the rollers down to the base to aid head location for felling

- Running the harvesting head down the stem to locate the base (Figure 3).

This method provides a solution but application is limited with larger trees [6]. Larger trees may require multiple felling cuts with head relocation and this requires an experienced operator. Where visibility to the tree base is restricted, care is required to ensure safety and/or mechanical damage as there is potential that harvester head grip may be lost, particularly with buttressed trees.

Several methods are available to improve the operator's view during mechanised harvesting in stands with dense natural regeneration. The simplest technique, with trees that can be felled with a single cut, is to place the harvester head on the stem above the regeneration and run it down to the base, guided by the feed rollers.

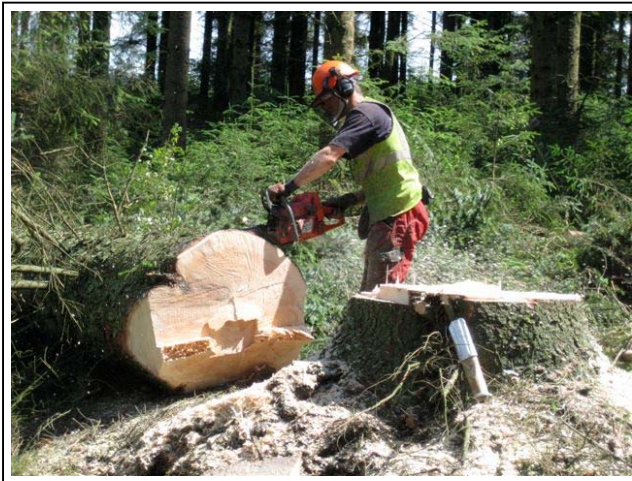
Figure 4 Motor manual felling to assist mechanised harvesting in CCF

- Combining motor manual felling with mechanised harvesting (Figure 4).

Combining mechanised and motor manual felling enables large trees in dense regeneration to be felled or debutressed for subsequent working by the harvester [5]. This is an effective method for overcoming difficulties with reduced visibility. A shortage of motor manual sawyers skilled in large tree working may limit the use of this method.

If large diameter trees are debutressed, there is a greater likelihood that the harvester operator can run the head down the stem and fell the tree without multiple felling cuts. If multiple felling cuts are required due to their diameter repositioning the head and gripping the tree will be easier because the buttresses have been removed.
