Heartwood Forest Access, Sandridge
Stage 1 Road Safety Audit

Woodland Trust
July 2009

1 Introduction

This report results from a Stage 1 Road Safety Audit carried out for the proposed priority junction access arrangement to Heartwood Forest in Sandridge, Hertfordshire. The audit was carried out at the request of the Design Organisation: EAS Transport Planning Ltd on behalf of the Woodland Trust.

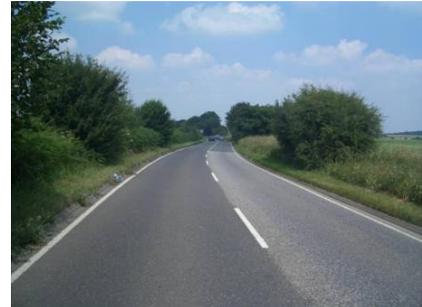
Location: Hedgerow and vegetation fronting the B651

Summary: Clearance of existing hedgerow to achieve proposed visibility splays

No details are shown to identify the extent of the existing vegetation which is to be cleared for achieving the visibility splays proposed. The auditors noted that a considerable area of the existing hedgerow along the western frontage of the B651 will require removal. As no details of the proposed landscaping and site clearance have been provided, the auditors are unable to comment further on the potential road safety implications.

In addition, the existing vegetation will require removal at the following locations:

- a) Vegetation will need to be removed on the approaches to the proposed junction to ensure unobstructed visibility between pedestrians waiting at the uncontrolled crossing points on the access road and approaching vehicles
- b) Removal of the existing vegetation will be required to ensure unobstructed visibility to the relocated speed limit signs and gateway features.

Failure to provide sufficient visibility on the exit and approaches to the junction is likely to result in the increased risk of conflict.

The auditors noted that the existing hedgerow fronting the B651 helped to demarcate the horizontal alignment of the carriageway. Clearance of the hedgerow on the approaches to the proposed access is therefore likely to reduce the demarcation of the carriageway alignment, and could increase the risk of loss of control collisions on corners (particularly for road users travelling at inappropriate speeds during dark or poor visibility conditions). Additional measures will therefore be required to improve the conspicuity of the carriageway alignment.

The hedgerows on the approaches to the proposed access will require removal to achieve the visibility splays proposed. Details of the proposed landscaping and removal of the existing vegetation should be provided in future road safety audit submissions. Consideration should be given to periodic maintenance, particularly during summer months, to ensure sufficient visibility is retained.

Forward visibility to all regulatory signs should be maintained in accordance with Chapter 3 of the Traffic Signs Manual.

Additional measures will be required to improve the conspicuity of the carriageway alignment. This could be achieved through the provision of verge side marker posts with reflective bands on the corner radii to help delineate the carriageway alignment where the existing hedgerow is to be removed.

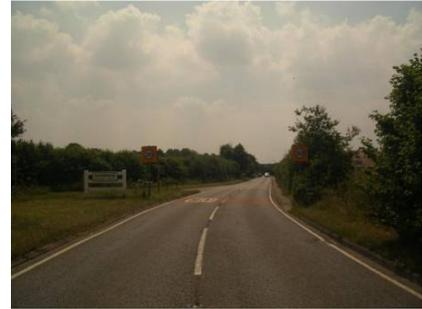
Location: Western kerblines of the B651 at the access to Heartwood Forest

Summary: Gully and dropped kerb located within the proposed access area

An existing gully is situated along the western kerblines of the B651, north of Coleman Green Lane, within the area proposed for the vehicular access to Heartwood Forest. Retaining the existing gully could present a slip hazard for cyclists and powered two wheelers turning into the access (particularly during damp or wet conditions), and could result in ponding along the western kerblines to the south of the access.

A dropped kerb is also located along this kerblines, at the termination point of the public footpath. It is unclear if this is to be relocated as part of the scheme proposals, and how the existing provision will tie-in with the proposed pedestrian facilities to the new development.

A drainage / level survey should be undertaken and the existing gully relocated outside of the junction mouth where recommended. Clarify whether the existing dropped kerb is to be retained or relocated as part of the scheme proposals.

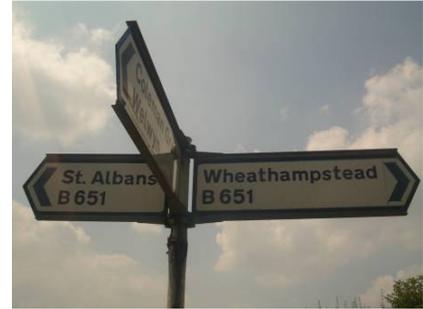
Location: B651 junction with the proposed access to Heartwood Forest

Summary: No destination signing proposed to identify the access to Heartwood Forest

No local (or tourist) destination signs are shown to indicate the location of the access to Heartwood Forest. This is a particular issue as Heartwood Forest is expected to attract up to 80,000 to 100,000 visitors per year, as stated in the Transport Statement. It is likely that visitors unfamiliar with the local area or forest location may hesitate on the approach to the access due to inadequate signing, leading to excessive braking, sudden turning manoeuvres and potential shunt-type collisions.

Local destination (or tourist destination) signs should be installed on the approaches and / or opposite the proposed junction access.

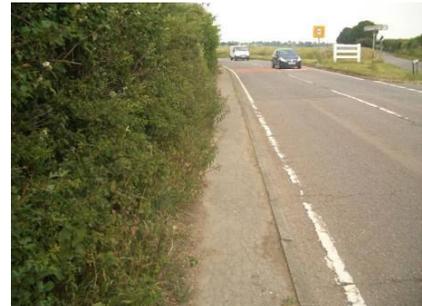
Location: Proposed gateway features on the B651 approaches to the proposed access

Summary: Location of proposed gateway features

The proposed gateway features, in particular those located on the western verge, are likely to be positioned amongst the existing hedgerow and vegetation. The existing vegetation is likely to obstruct forward visibility to the gateway features. Poor visibility to the gateways is likely to reduce the effectiveness of the feature as a traffic calming measure.

In addition, the gateway feature along the western side of the B651, to the north of the proposed access, is shown to be located across the existing footpath. The slopes of the verges along both sides of the carriageway may present a construction issue upon implementation of the gateway features. No details of landscaping have been provided for the auditors to comment further.

The gateways should be sited in an area of the verge with sufficient forward visibility for approaching traffic and without obstruction of pedestrian desire lines. Details of the proposed landscaping and removal of the existing vegetation should be provided in future road safety audit submissions. Regular maintenance of the vegetation is likely to be required.

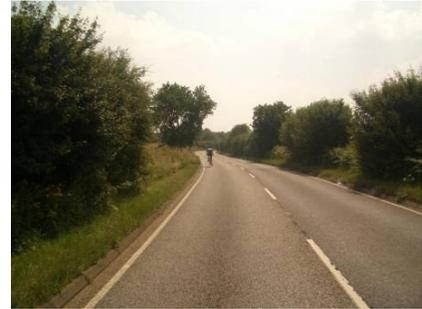
Location: B651 proposed speed limit extent

Summary: Speed limit signing may be obscured by vegetation, and less conspicuous than existing

The existing 30/40mph speed limit signs on the B651 are to be relocated north of the proposed access, within close proximity to existing vegetation along both frontages of the B651. A 30mph speed limit roundel is also proposed to be located within the southbound carriageway, a few metres south of the speed limit terminal signs. The proximity of the vegetation is likely to partially obstruct forward visibility to the signs, whilst it is unclear why the proposed 30mph roundel marking is to be located away from the speed limit terminal signs.

For the reasons stated above, the proposed layout is likely to be less conspicuous than the existing arrangement provided immediately north of Coleman Green Lane, where a red surface treatment and carriageway roundel markings have been installed alongside the speed limit terminal signs. Reduced conspicuity of the speed limit signing and markings may encourage poor speed compliance on the southbound approach to the proposed access, increasing the risk of speed-related collisions.

The audit team also noted that the 40mph 'transition zone' between the National Speed limit and relocated 30mph is to be significantly reduced in length from approximately 250m to 140m. Reducing the transition distance over which the speed limit is reduced is likely to further encourage poor speed compliance on the southbound approach to the proposed development access, increasing the risk of potential speed related or shunt-type collisions.

A layout similar to the existing 30/40mph speed limit transition north of Coleman Green Lane should be provided for the proposed arrangement north of the access. A red surface treatment and carriageway roundel markings should be provided alongside the speed limit terminal signs to improve conspicuity of the change in speed limit and encourage compliance of the speed limit.

The existing length of the 40mph 'transition zone' should be retained, with further traffic calming measures required if speed compliance is likely to be an issue on the approaches to the proposed access. Staggered junction ahead warning signs to TSRGD Diag. 507.1v could be installed on the B651 approaches to the junction to further encourage motorist caution whilst approaching the access and Coleman Green Lane.
